BIRDSALL ENGINEERING, INC.
CONSULTING & ENVIRONMENTAL ENGINEERS

September 5, 2006
Proposal No. BEI060905RCM1

Re: **Capital Place One**
222 South Warren Street
Trenton, NJ

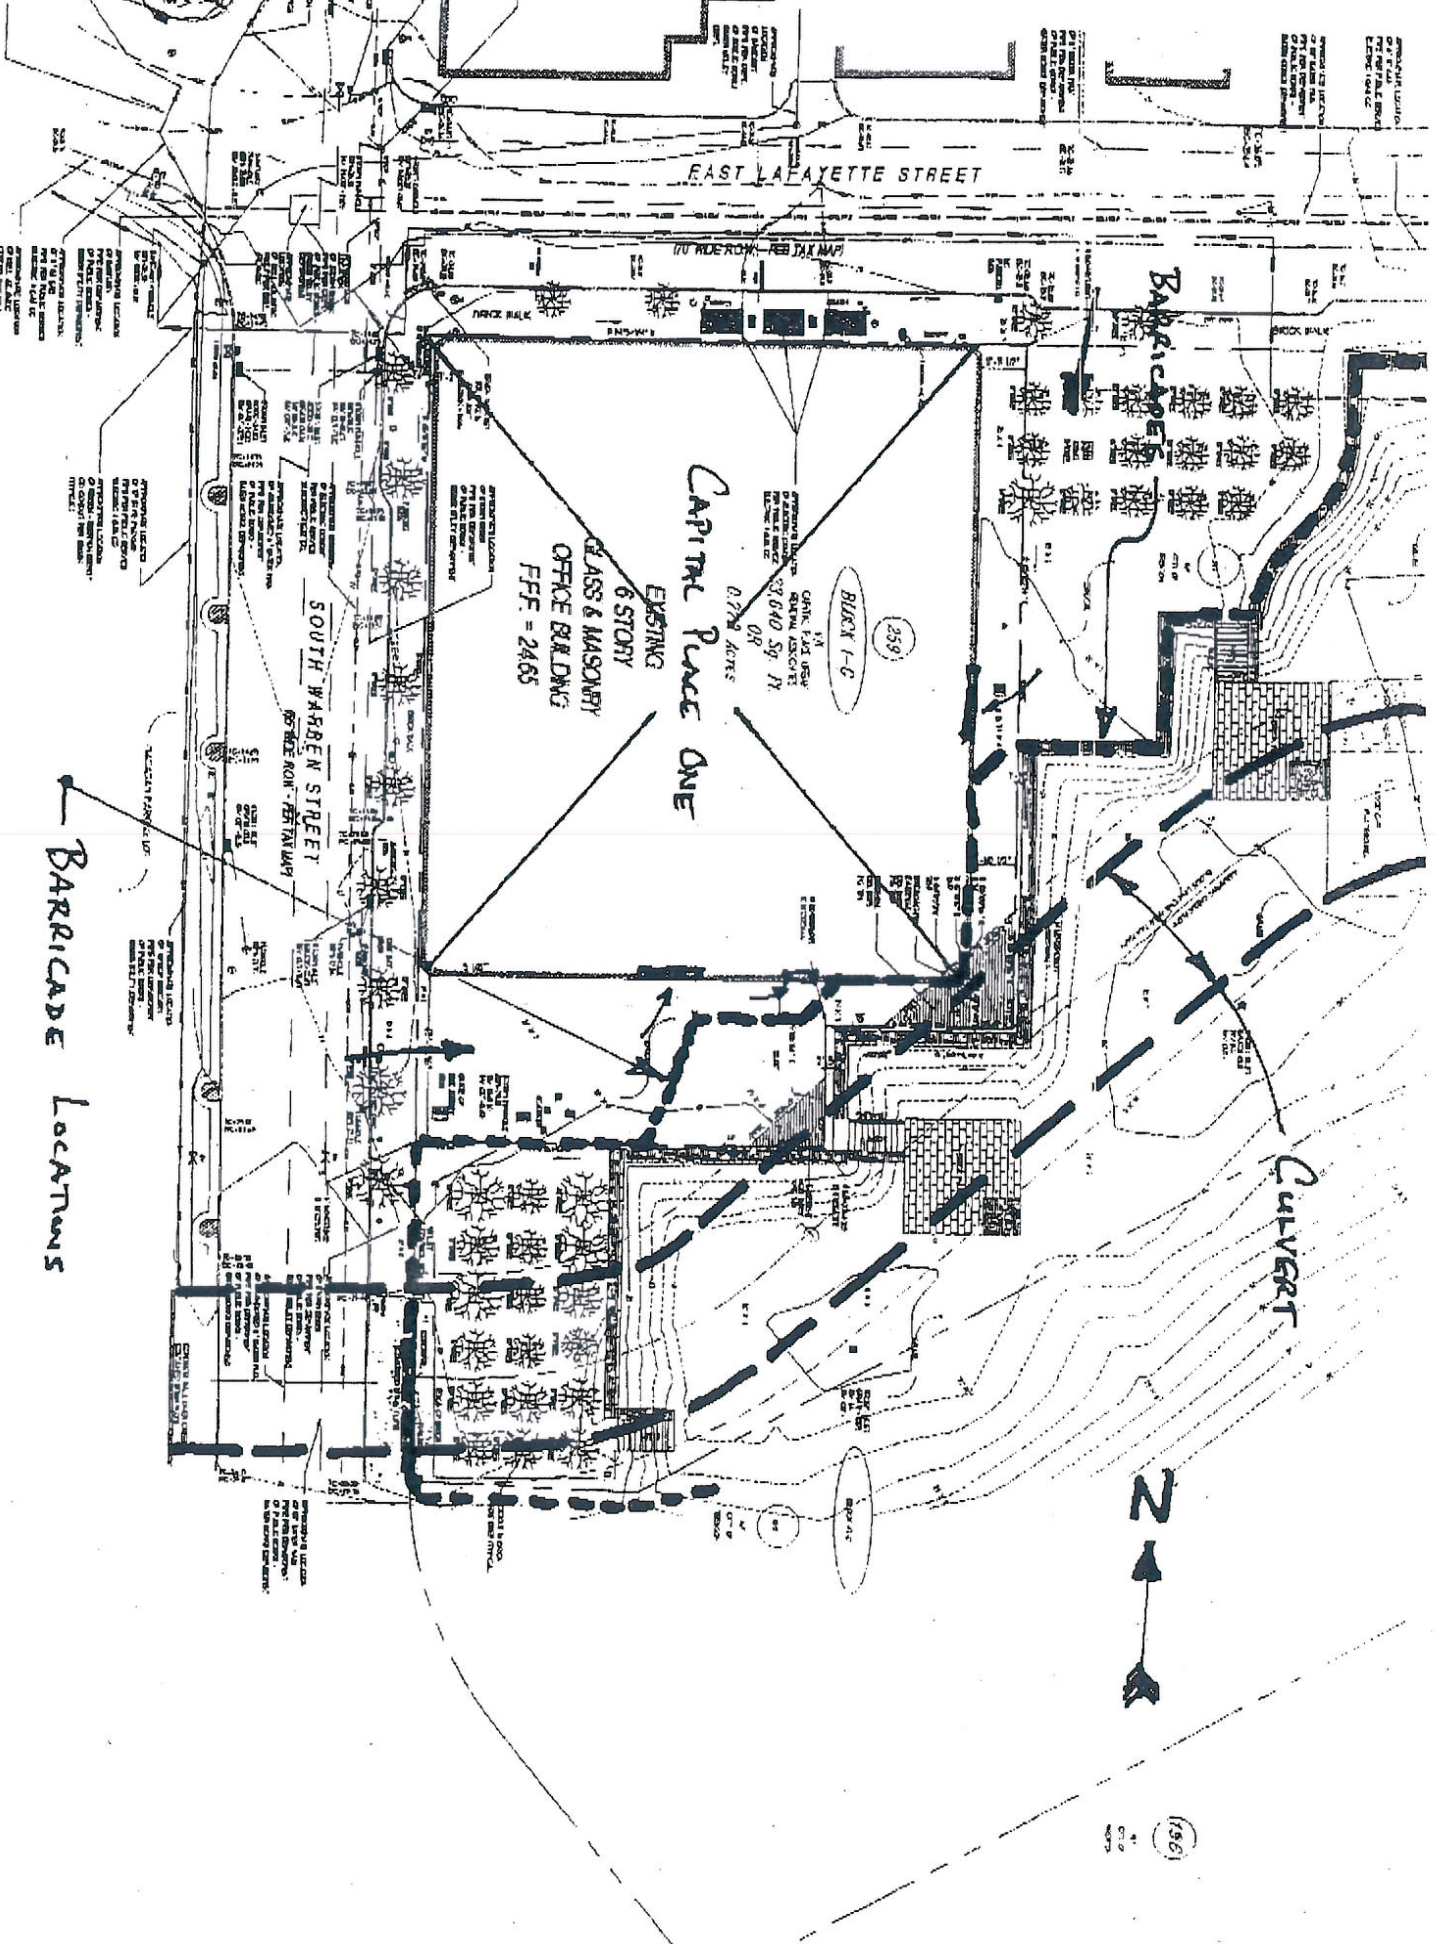
1 SITE SURVEY
SCALE: 1"=20'

With regards to the actual building, Capital Place One, review of the structural drawings indicate that the building structure is supported on steel H-piles that extend down to "ledge rock". The perimeter grade beam of the building is thickened to 12'-6" at the Southeast corner of the building to apparently address the existence of the culvert structure. With the failure being related to the culvert roof slabs and the building being independently supported on its own deep foundation system, the structural failure of the culvert roof does not compromise the structural integrity or safety of the building structure. It is our professional opinion that it is safe to occupy and use Capital Place One as long as external access is restricted from the areas over the culvert roof and a 10' buffer on each side of the culvert as was outlined in the field at the time of the inspection and as marked on the attached plan of the building site.

BARRICADE LOCATIONS
